## RELEVANT ASSETS - FOCUSED FOLLOW-UP

# Keep Each Trade Focused on Visible Work.

## ILLUSTRATIVE PICTURE REPORT

### Landscape border and adjacent vegetation need maintenance

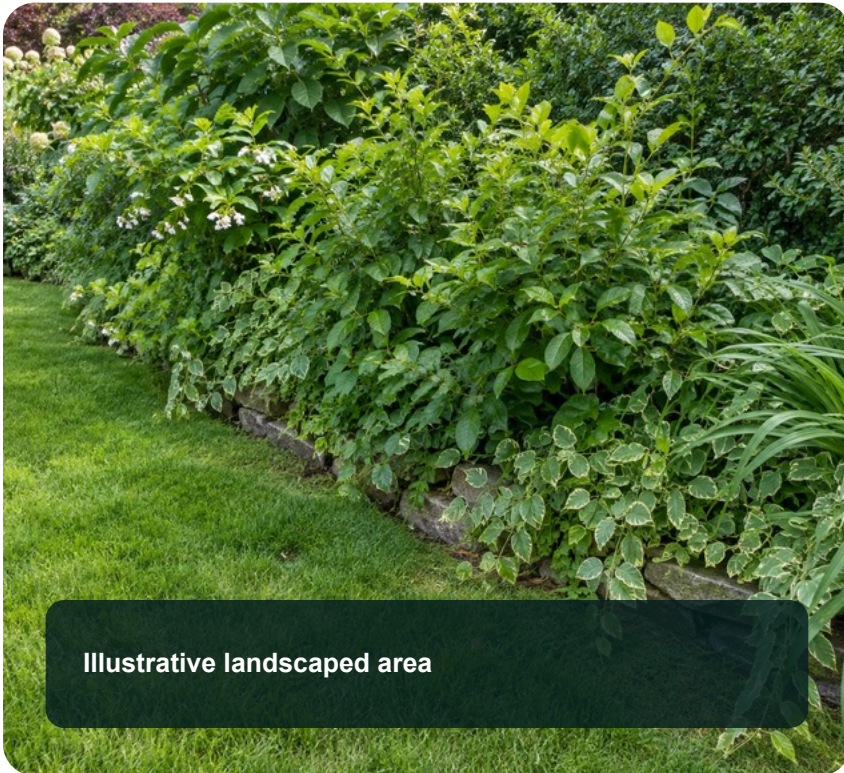
The border alignment and nearby vegetation appear uneven, with visible encroachment into the maintained edge. The photo does not establish plant health, irrigation performance or below-grade conditions.

Confirm the intended landscape limits and plant material. Remove unwanted growth, reset or replace displaced edging, restore the bed profile, inspect irrigation coverage and document the finished boundary without damaging roots or utilities.

Compatible landscape edging and stakes, approved mulch or soil amendment, hand tools, irrigation repair fittings if needed and temporary work-area markers.
